AIRFIELD PAVEMENT EVALUATION

SPRINGFIELD

AIR NATIONAL GUARD BASE

OHIO

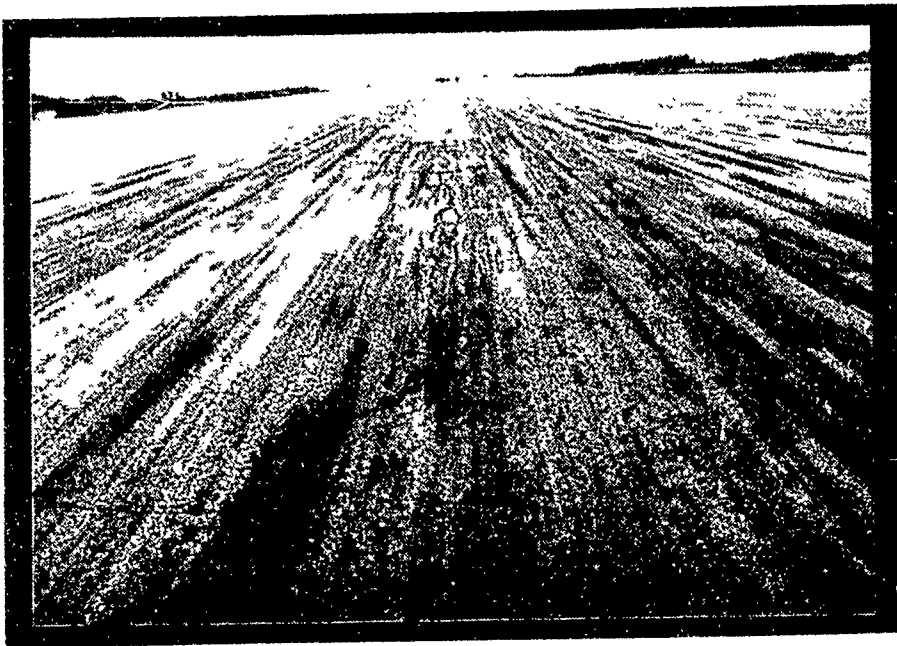
The longitudinal alligator cracking pattern that is present along most of the centerline is shown in photos 1 and 7. Maintenance crews have poured sealant in some of these crumbling AC areas to prevent the AC from "blowing out" any

PHOTO 1 : ALLIGATOR CRACKING ON CENTERLINE OF RUNWAY 06/24 (TYPICAL).

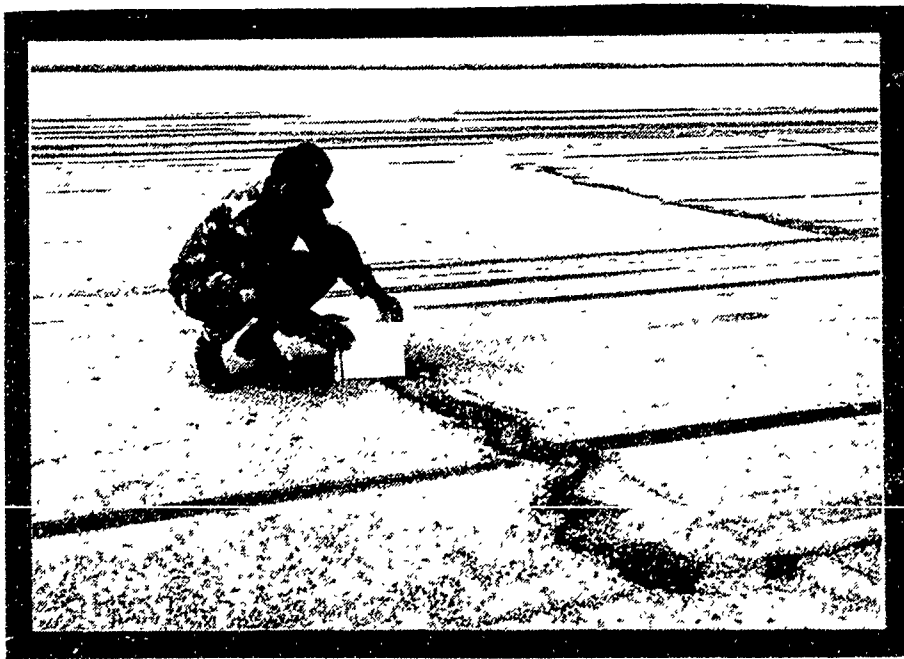
Feature R5C has PCC directly below the AC, and the joints are beginning to reflect. This feature rates FAIR. There are some significant cases of shoving where a severe transverse crack in the PCC is breaking up and shoving the AC, causing a raised lip at the surface (photo 4). Feature R4C is the worst portion of the runway and rates VERY POOR in condition. The distresses (alligator and shrinkage cracking) are the same as within Features R2A and R3C, just more severe. Features R2A and R3C rate POOR. The intersection of both runways is in slightly worse condition, possibly due to aircraft turning here.

PHOTO 4 : UNDERLYING PCC CRACK OF JOINT WHICH HAS DETERIORATED AND HAS CAUSED SHOVING OF AC SURFACE.

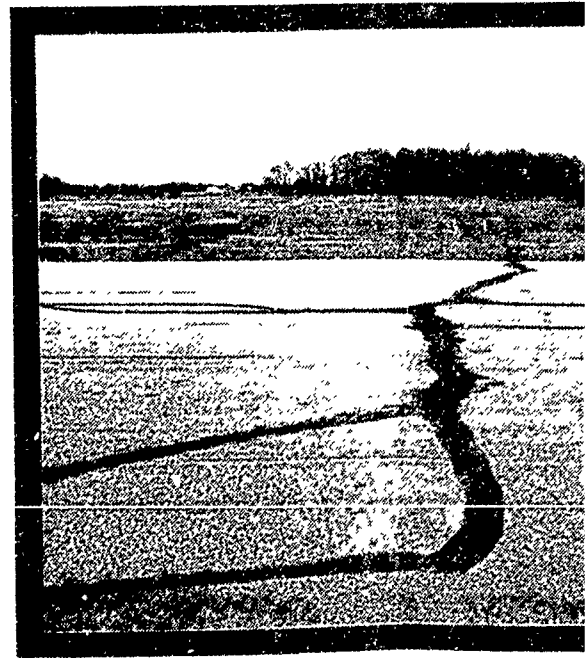
PHOTO 5 : HIGH SEVERITY TRANSVERSE SHRINKAGE CRACK EXTENDING (TYPICAL ON RUNWAY 06/24). CRACKS ARE TOO WIDE WITHOUT A BACKER ROD.

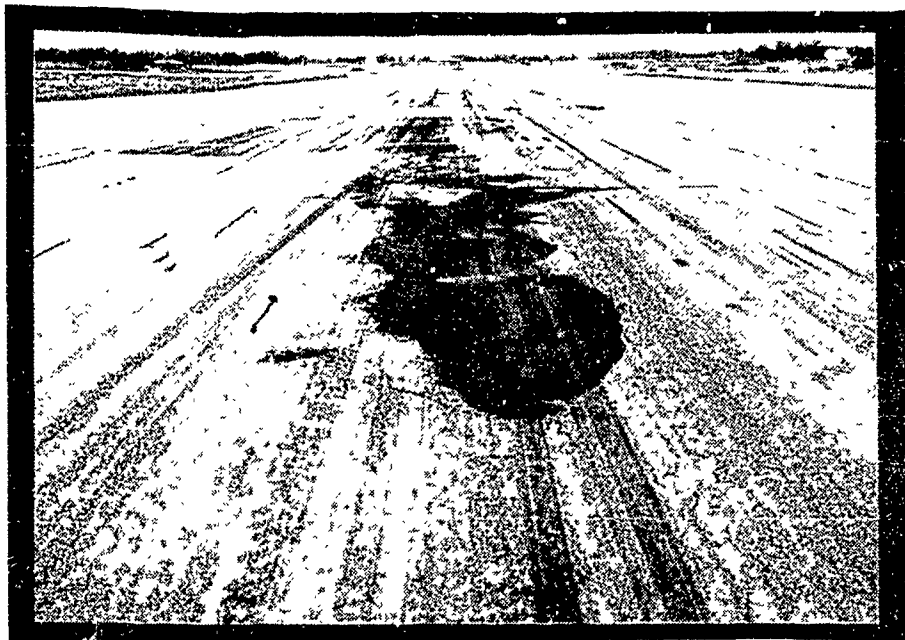
further (photo 3). Alligator cracking has also developed along transverse shrinkage cracks such as shown in photos 8 and 9, where infiltrating water has weakened the base material. Photo 6 shows a longitudinal crack that has developed the same alligator crack pattern from a weakened base. The transverse shrinkage cracks are as wide as one-inch. Photos 5 and 10 show these wide cracks. Another less significant distress is the surface deterioration where paint markings have been placed (photo 2). The difference in thermal expansion of the paint and the AC causes tension stress at the interface, and thus the deterioration.

PHOTO 3. MAINTENANCE CREWS HAVE POURED SEALANT ON CRUMBLING AC AREAS TO PREVENT AC FROM "BLOWING OUT" FURTHER (TYPICAL FOR FEATURE).

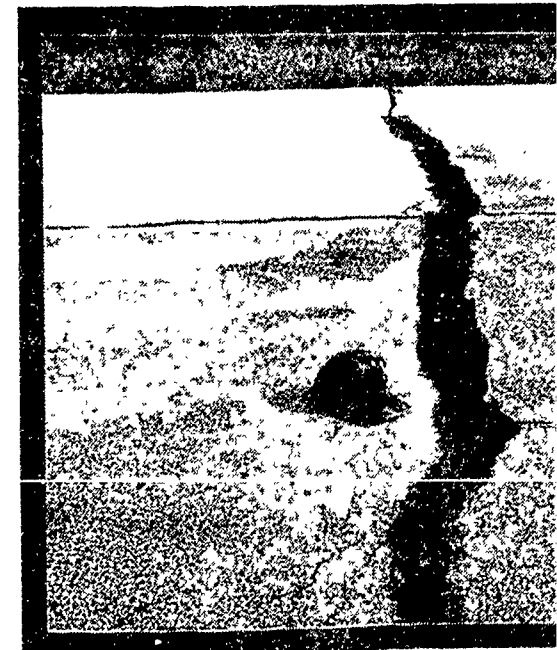
PHOTO 10 TRANSVERSE SHRINKAGE CRACKS SUCH AS THESE WIDE (TYPICAL).

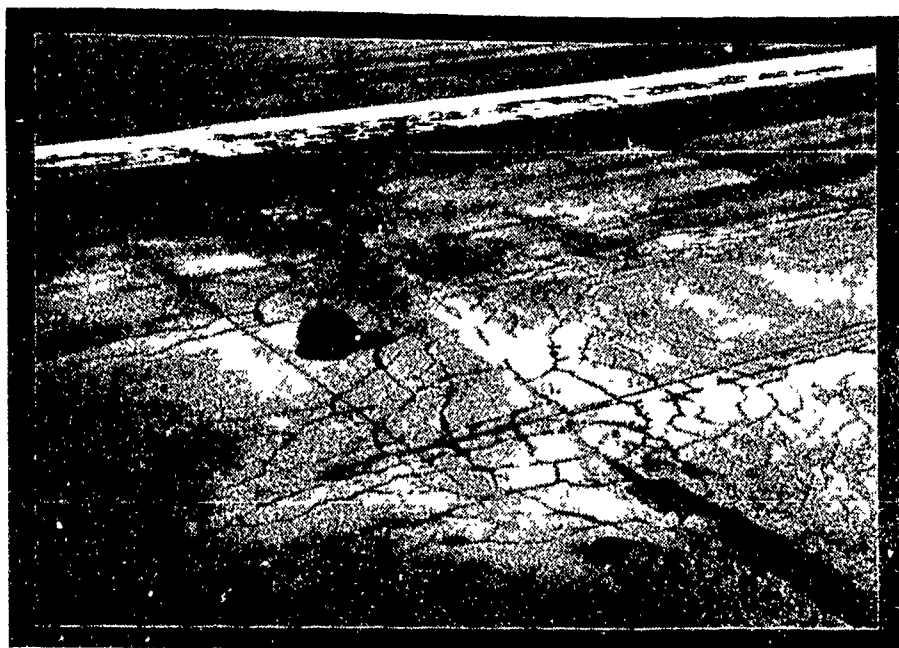
PHOTO 8, STRUCTURAL CRACKING ON RUNWAY 06/24.

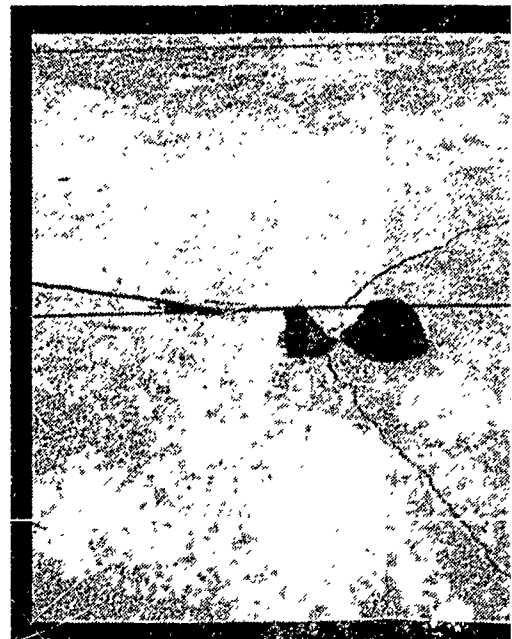
PHOTO 15: LOW SEVERITY CORNER BREAK ON APRON WHEN

1. The cracks in the ANG Apron should be routed and sealed. The PCC will spall if left unattended.
2. The transverse shrinkage cracks in Taxiways A, B, C, G, and F should be routed and sealed ASAP. Backer rod will be required if the crack is wider than 3/4-inch. The AFCESA Asphalt Crack Repair Field Manual will be sent to the 178 TFG/DE and should be helpful.
3. Paving lane cracks in Taxiway B and Taxiway G are less than an 1/8-inch wide. Sealing them now, just as Taxiway A was done, will greatly deter the cracks from getting worse.
4. Seal the few joints in the north Arm/Dearm Pad that have no sealant. This feature (T12A) will require joint resealing in a few years.

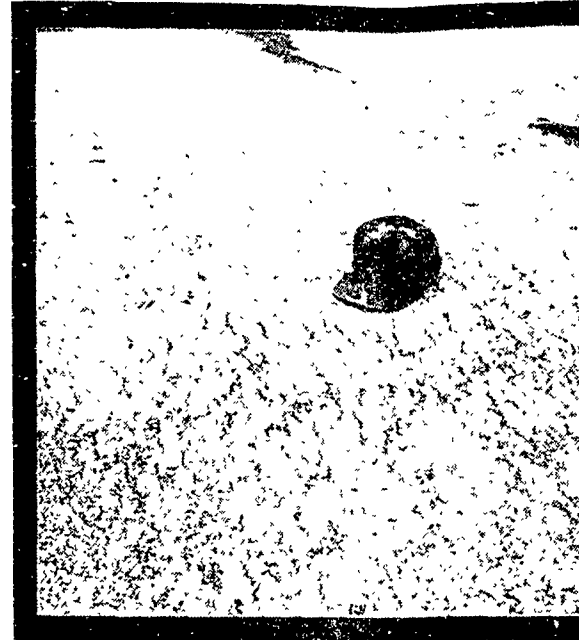
PHOTO 22: FINE TRANSVERSE CRACKS CAUSED FROM AC MIX BE OF TAXIWAY A. THESE SHOW UP BEST WHEN PAVEME
